DEPARTMENT OF TRANSPORTATION

Contract #: 04-0120F4Cty: SF/ALA Rte: 80 PM: 13.2/13.9File #: 99.28**WELDING INSPECTION REPORT****Resident Engineer:**Siegenthaler, Peter**Address:** 333 Burma Road**City:** Oakland, CA 94607**Report No:** WIR-022552**Date Inspected:** 06-Nov-2010**Project Name:** SAS Superstructure**OSM Arrival Time:** 700**Prime Contractor:** American Bridge/Fluor Enterprises, a JV**OSM Departure Time:** 1900**Contractor:** Zhenhua Port Machinery Company, Ltd (ZPMC) Chanxing Island **Location:** Shanghai, China**CWI Name:** Mr. ZHU ZHONG HAI**CWI Present:** Yes No**Inspected CWI report:** Yes No N/A**Rod Oven in Use:** Yes No N/A**Electrode to specification:** Yes No N/A**Weld Procedures Followed:** Yes No N/A**Qualified Welders:** Yes No N/A**Verified Joint Fit-up:** Yes No N/A**Approved Drawings:** Yes No N/A**Approved WPS:** Yes No N/A**Delayed / Cancelled:** Yes No N/A**Bridge No:** 34-0006**Component:** OBG Segment**Summary of Items Observed:**

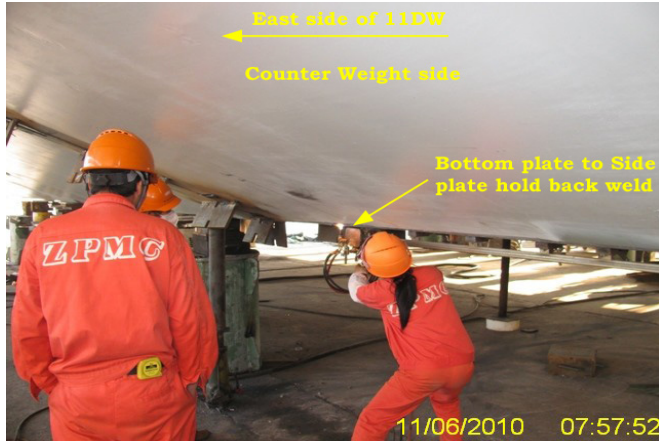
ZPMC personnel performing oxy acetylene cutting of shop weld for the bottom plate to side plate hold back weld joint located on east side of 11DW at counter weight side due to the misalignment. ZPMC QC Mr. ZHOU PENG was onsite monitoring the variables. The weld repair report number is named as CWR-2139. See attached picture for detail.
